Case Study  
Andreas Ruecker, MD

## Hip Fracture Management

TRIGEN® INTERTAN®  
Intertrochanteric Antegrade Nail  
with Integrated Interlocking Screws

Cephalomedullary nailing and  
intraoperative compression of a  
peritrochanteric hip fracture

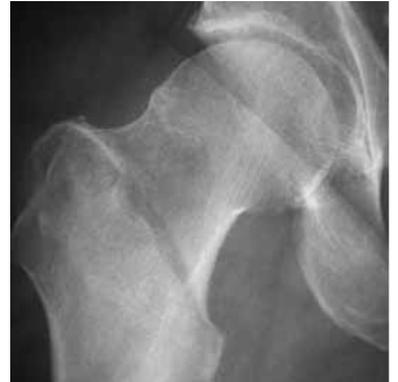
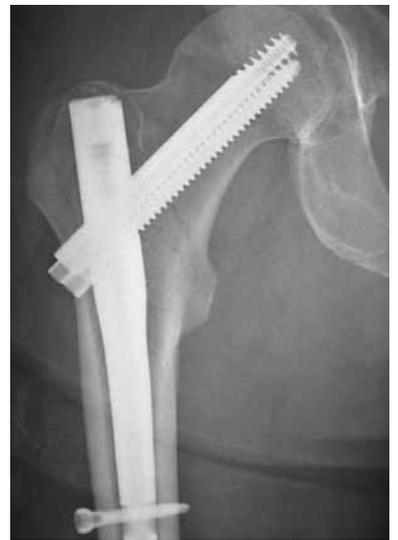
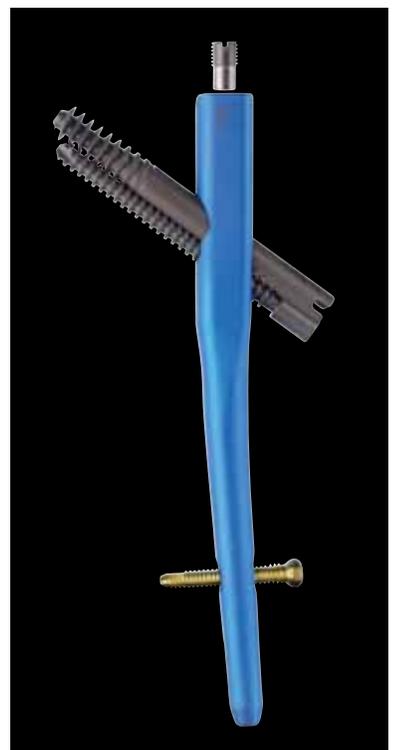
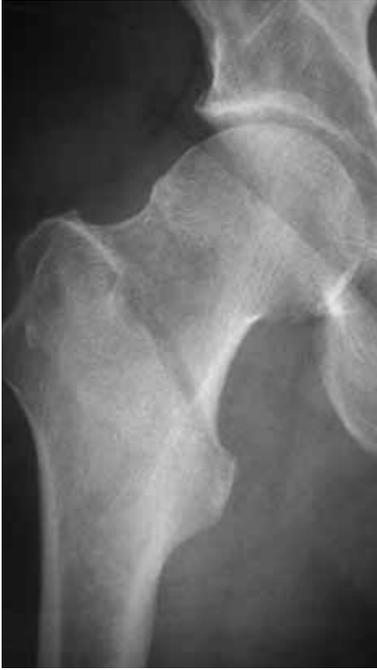
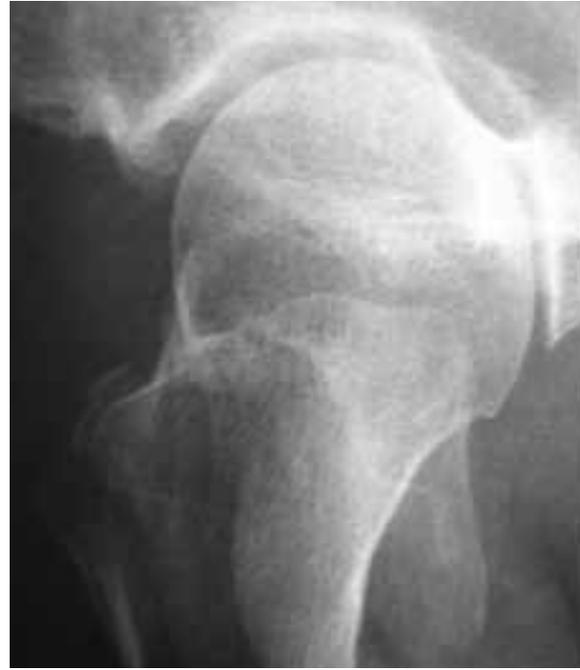
Preoperative radiographs

48-year-old male, injured in a fall  
causing a two-part peritrochanteric  
hip fracture

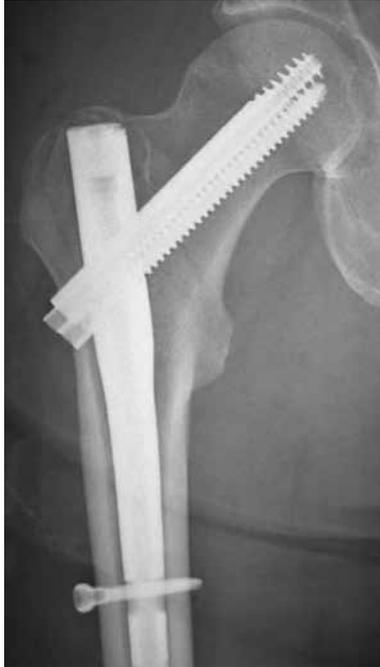
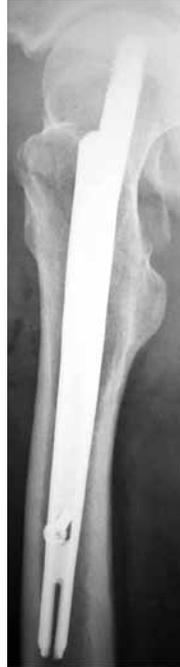
Postoperative radiographs

The procedure was performed with the patient in the supine position. The affected leg was placed in traction and a short INTERTAN® nail was introduced into the proximal femur. Integrated interlocking lag and compression screws were inserted through the nail into the femoral neck and head and the fracture was reduced via active linear compression. A 5.0mm locking screw was used to lock the nail distally.

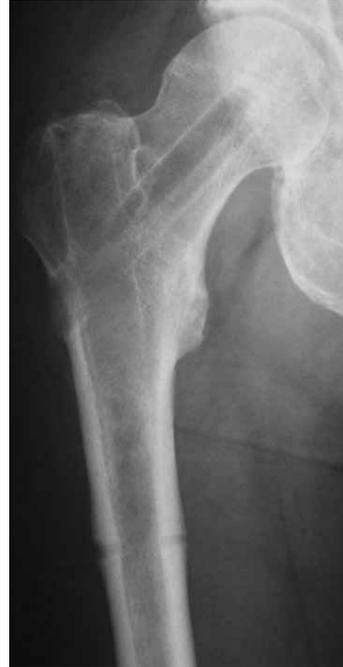
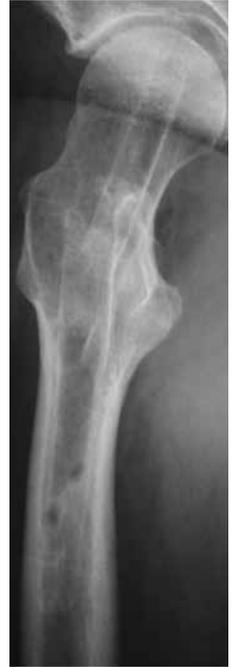
Post-removal radiographs

“On the X-rays taken after the removal you can see, that there never was any instability at any time (sclerosed outlining). I like that... He was absolutely satisfied with the whole outcome before and after his removal.”

The patient did not want the implant removed, but claimed that he “sometimes (felt)... something in his upper thigh... no pain, just a kind of disturbance after running 5 miles.” The implants were subsequently removed and all noticeable disturbance disappeared.
